**Re: Application No. 03-0491Z
Substitute No. 1 to Ordinance 03-041 to Rezone 1.38 Acres
From S (Suburban) to S and H (Historic) Zoning Overlay**

REPORT ON INSPECTION AND EVALUATION 2818 GRUBB ROAD - WILMINGTON

On December 1, 1998 and again on December 3, 1998, engineers from Tetra Tech performed an inspection of the house and storage barn located at 2818 Grubb Road in Wilmington. The purpose of this inspection was to document the existing construction, identify significant structural deficiencies, and develop recommendations for repair and correction of these deficiencies.

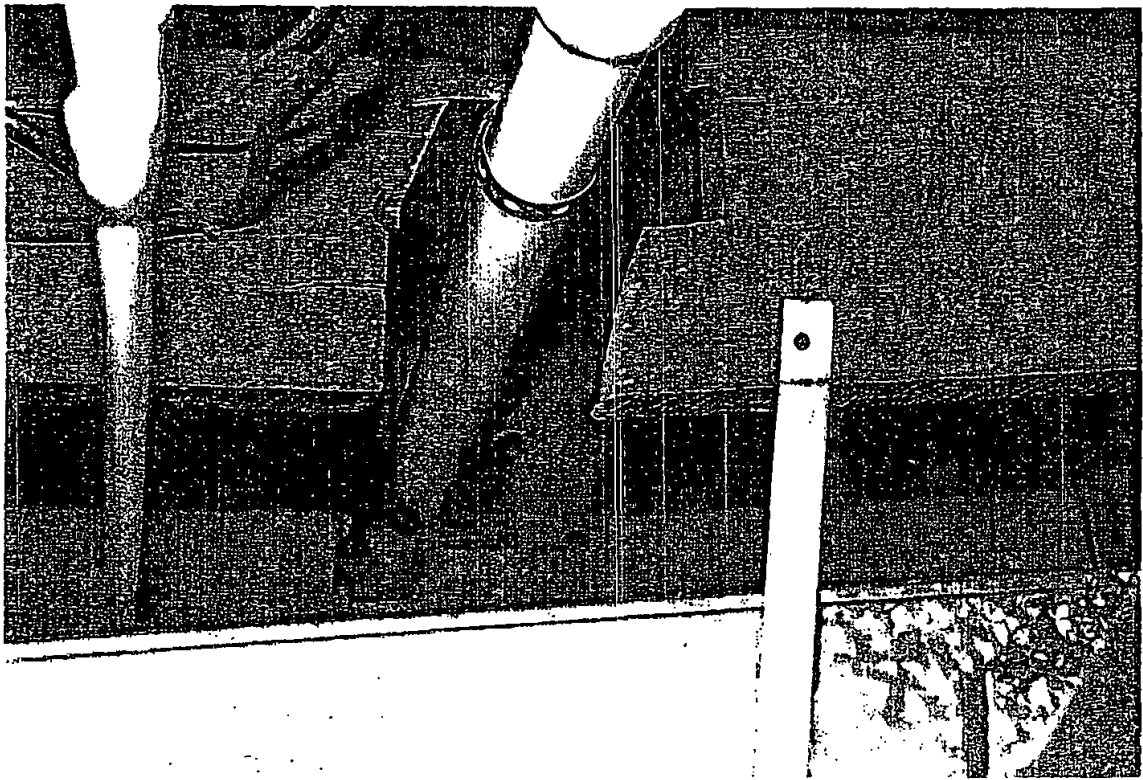
Several joists have been notched and cut, some extensively, to permit installation of pipes, ducts, and wiring.

First floor framing beams of main house, with holes
cut for installation of plumbing.

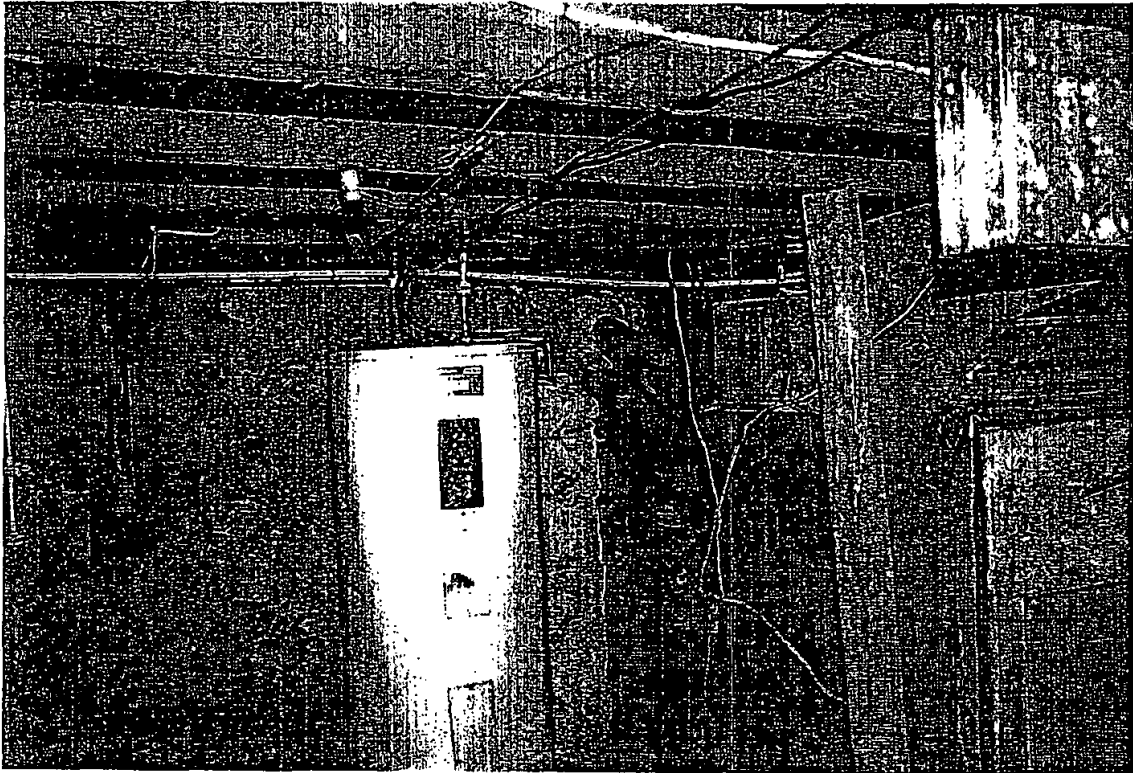
Puddles of water were noted on the basement floor. Parging had fallen from the foundation wall due to water seepage through the wall.

Floor joists are visibly sagging two to three inches at midspan. At one location a timber post has been placed under one joist as additional support.

First floor framing beams of main house. Note water on floor behind water heater, and post at right installed as support under one floor beam.

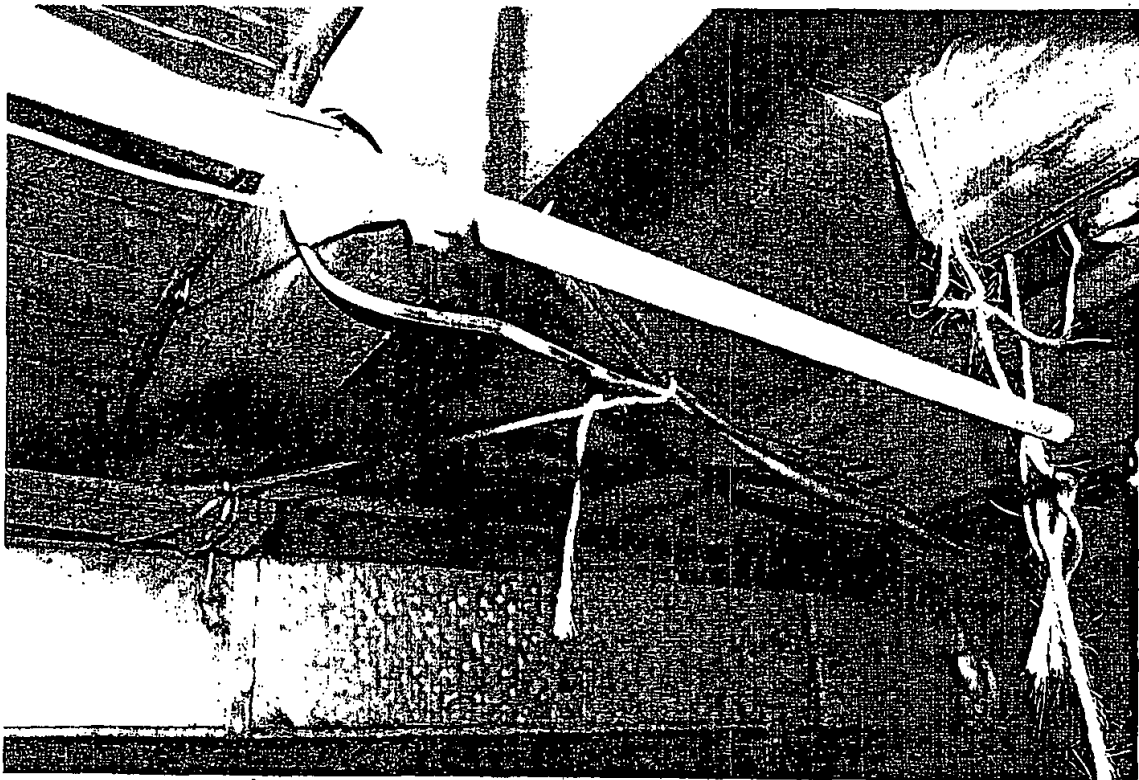
One floor joist has been completely cut away to permit installation of a mechanical duct.

First floor framing beam in main house partially removed
to allow installation of mechanical equipment.

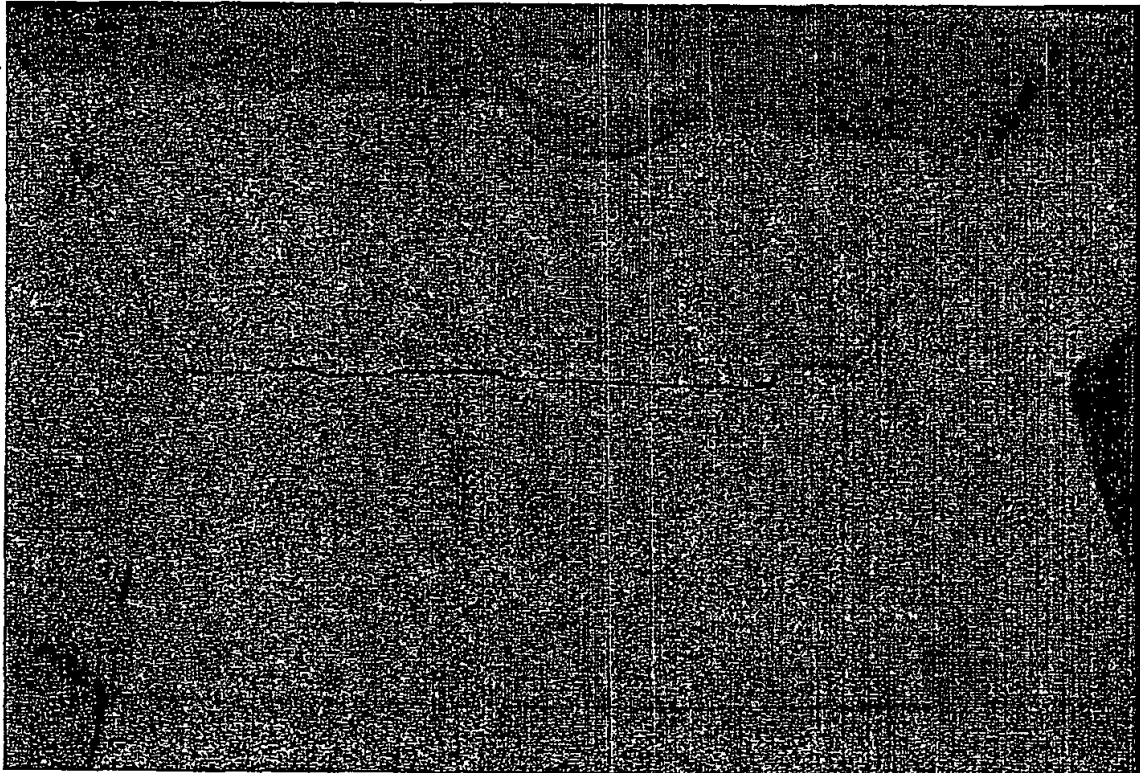
- A large crack was noted in the plaster at the intersection of the wall and the ceiling at the first level, in a closet under the stair leading to the second level.

Settlement crack in ceiling of closet located under the stairs
to the second level of the main house.
